# Failure Analysis of a Gas-Nitrided 15-5PH Steel

J. L. Golden, Ph.D.  
ASM Houston Chapter / Failure Analysis Seminar  
Houston, TX  
03 April 2012

ISS 2007 Configuration: Solar Alpha Rotary Joint (SARJ) Locations

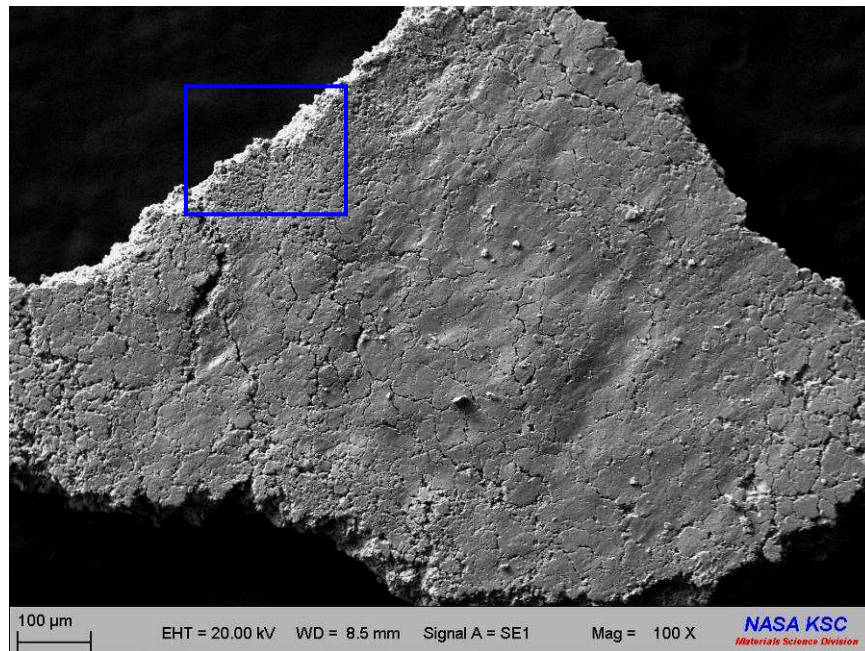
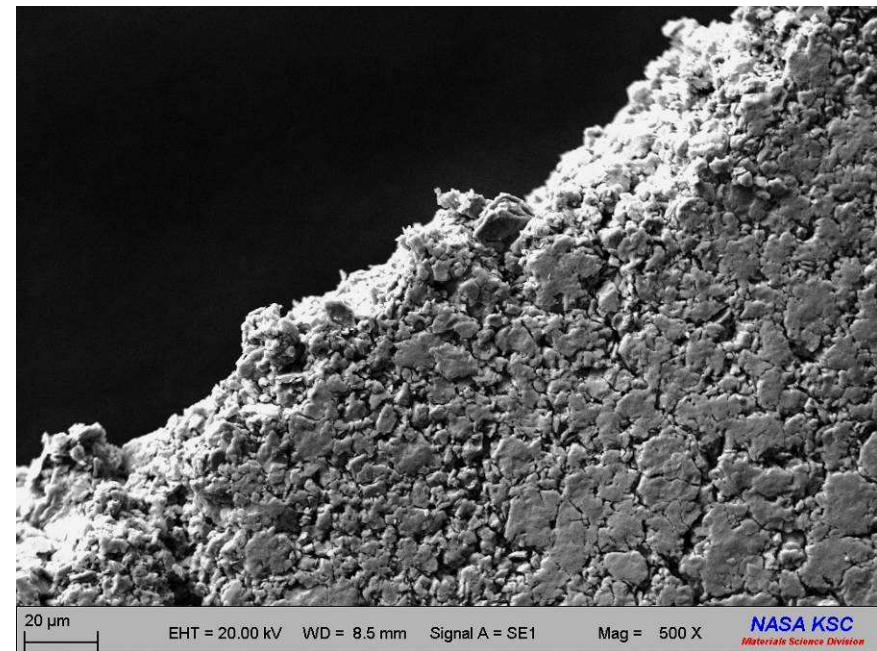
Nitrided 15-5 PH agglomerated fragment from Tape 31 imaged under high vacuum.  
Reference magnifications: 100X (left), 500X (right)

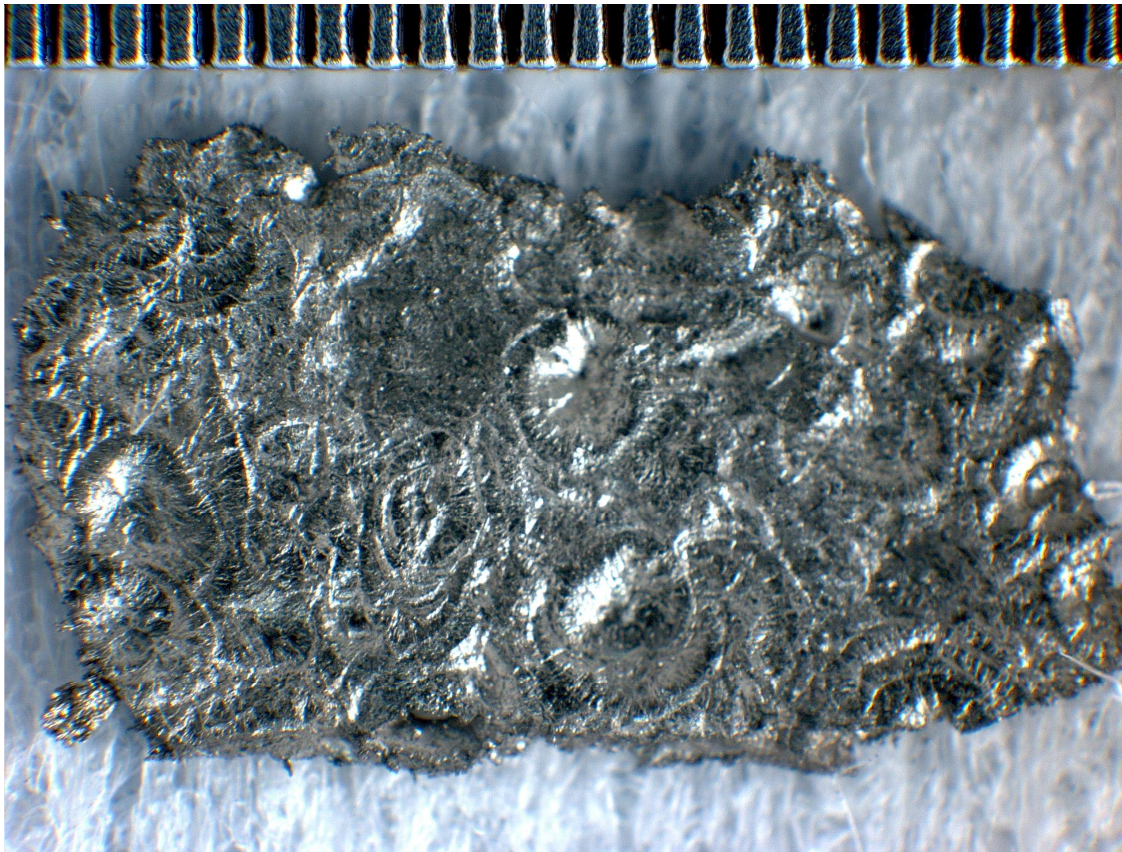
- Largest particle located was ~3mm x ~5 mm.
- Particle thickness was about 150-170  $\mu\text{m}$ , essentially equal to the nitride layer thickness.
- Numerous subsurface fracture initiation sites were observed, indicating a low-cycle fracture phenomenon took place.

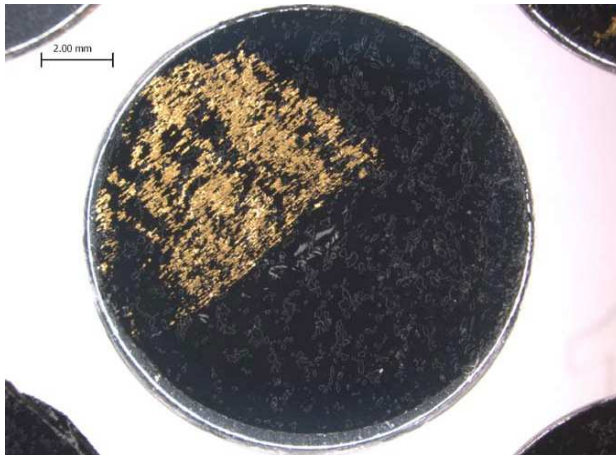
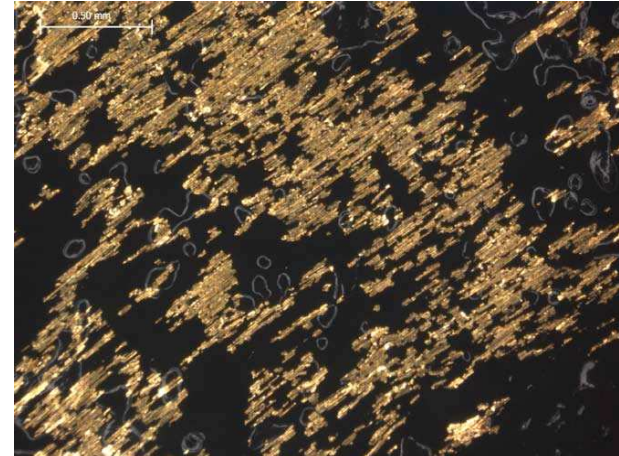
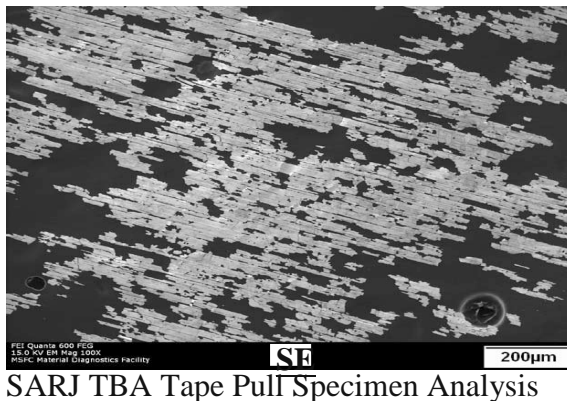
## TBA 1045, Datum A, Test #2, Carbon Tape

- Gold coating was easily removed from trundle bearing roller surfaces using carbon tape, and was generally segmented into strips of dimension consistent with the as-machined surface finish.

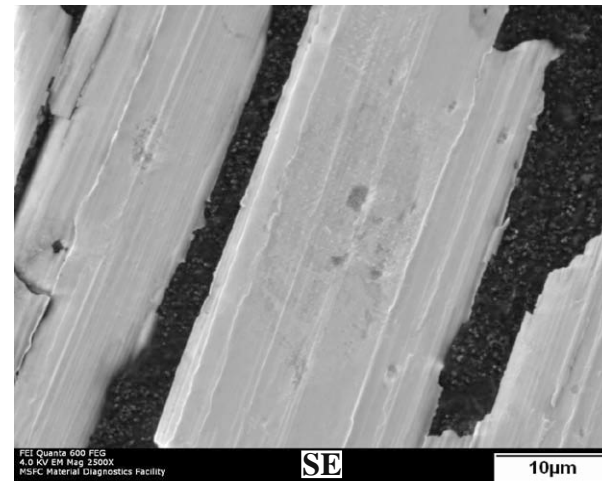
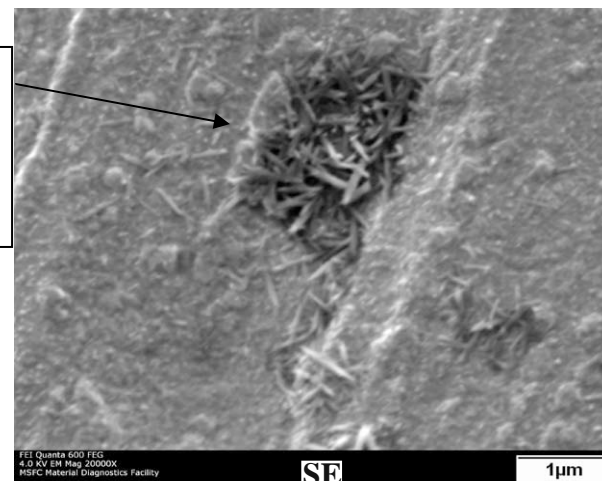
## TBA 1005, Outer 45, Test #1, SEM

Iron Oxide  
(by  
elemental  
analysis)

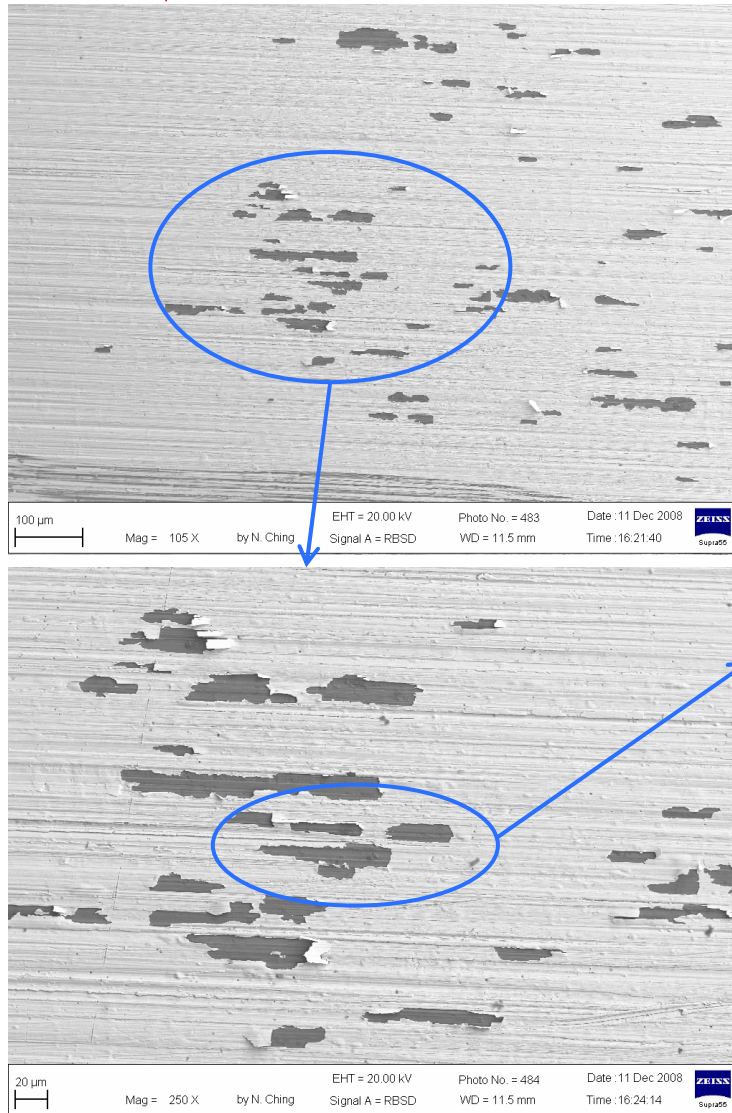
➤ Freshly gold-plated 440C after 21 days of 95%RH at 125°F.

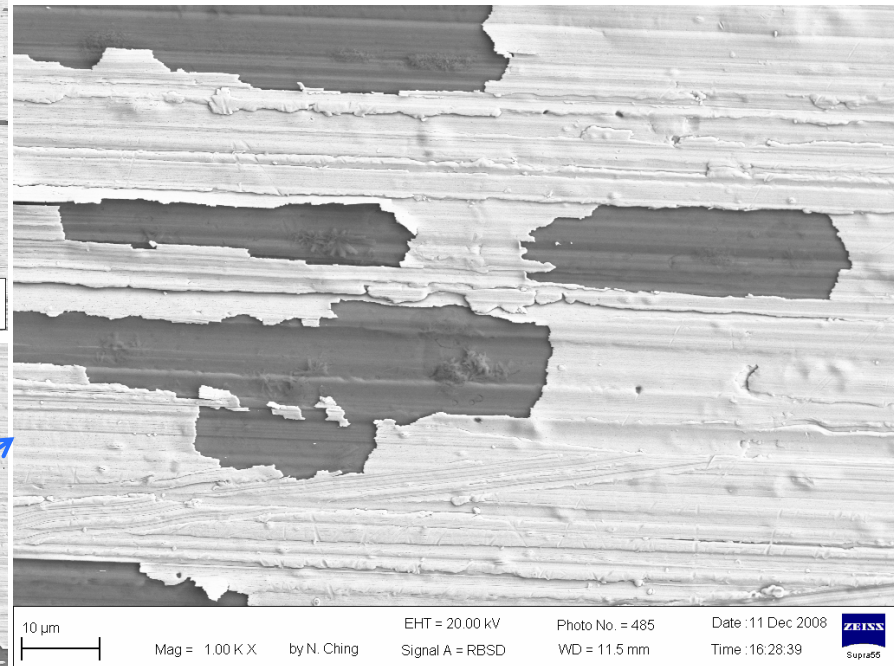
➤ Adhesion failure mode is consistent with that observed with trundle bearing rollers.
